# **Failure Forensics and Re-Design of Reversible Flow Draft Tube Trash Racks at a Pumped-Storage Plant**

## **Abstract**

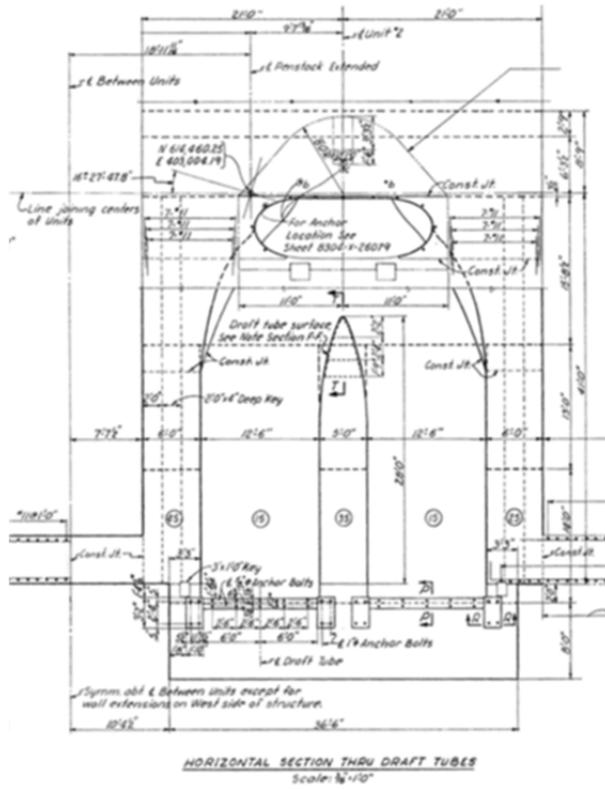
Figure 1: Draft Tube Arrangement for Each Unit

Ameren Missouri's Taum Sauk Pump-Storage Plant has two units, each rated at 225 MW. Trash racks are located at the exit of the draft tubes in the tail race of the lower reservoir. Each unit has a draft tube with dual exits (see Figure 1), and each trash rack slot contains a single steel trash rack at the draft tube exits with four timber racks on top (see Figure 2). During clean out operations of the tail race in 2006, portions of the steel draft tube trash racks were found in the tail race. Further inspection revealed that a similar portion of the draft tube trash racks was missing for each unit. The missing section occurred in the left trash rack of each unit and was the lower half of the steel rack.

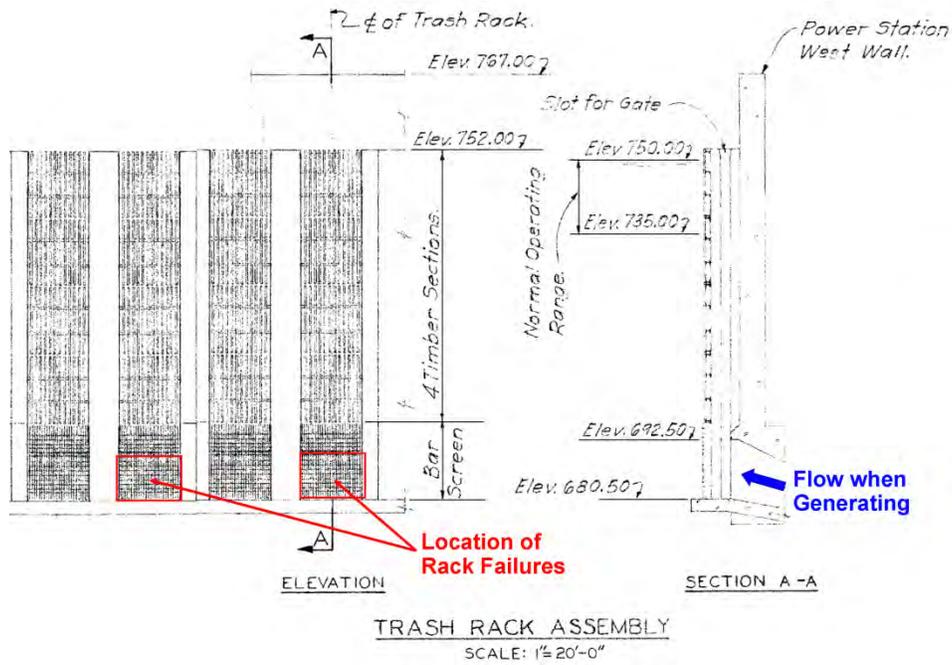
Figure 2: Trash Rack Arrangement

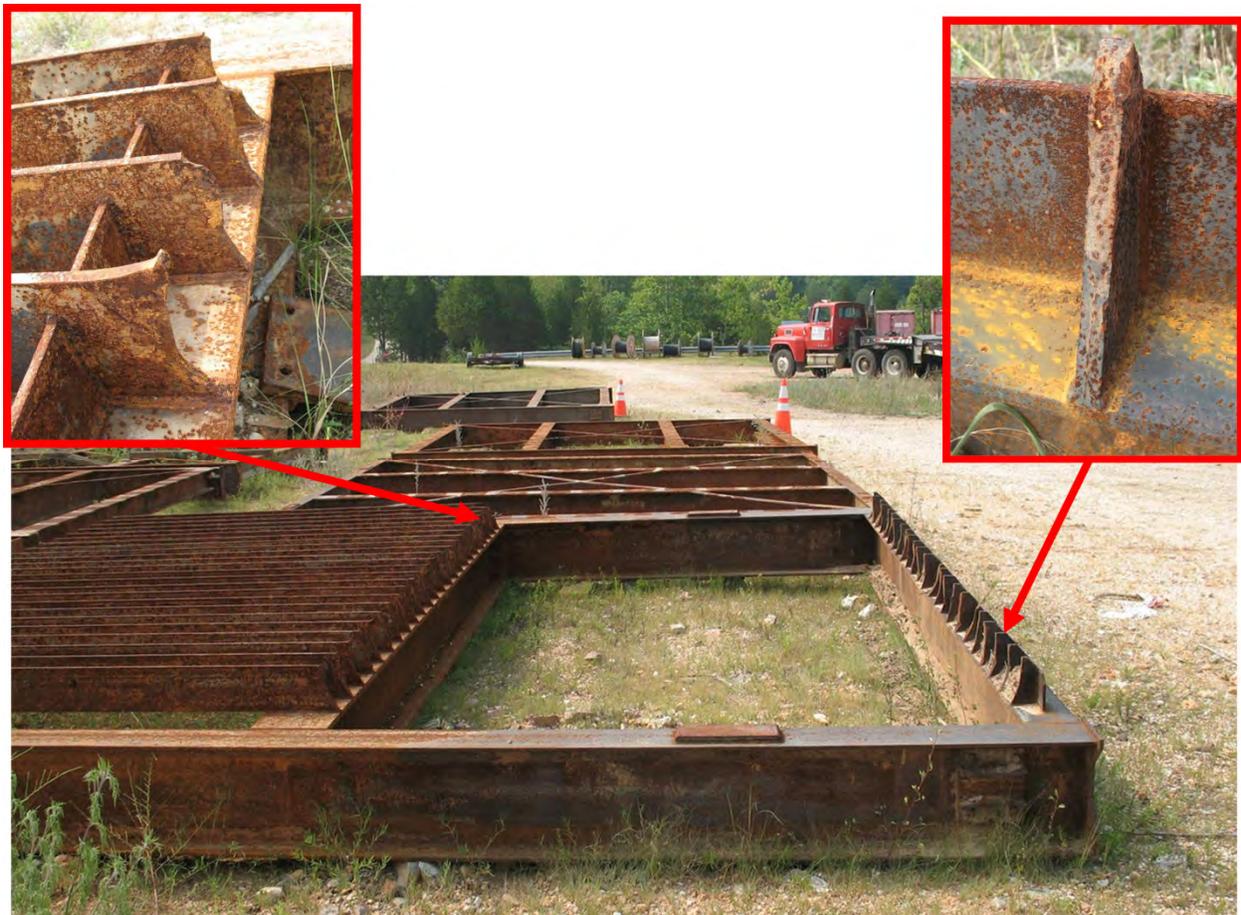
Figure 4 shows one of the failed sections of the draft tube trash racks. Additional inserts provide detailed photographs of a typical failure surface for the lower end of the failed portion of the rack (insert on the right-hand side in the figure) and several bars for the upper end of the failed portion (insert on the left-hand side in the figure). A preliminary examination of the failure surfaces suggested that the failure to the rack section may have occurred in three phases. Initially, fatigue cracks propagated from both sides of the lower ends of the vertical bars, likely due to excitation from flow-induced vibrations. Eventually, the fatigue cracks met in the middle of the bars, and the lower ends of the bars were sufficiently weakened to allow detachment of the bars at the bottom. Presumably, hydraulic forces acting on the detached portion of the trash rack swept the failed section downstream, quickly tearing away the upper portion of the bars. Subsequent metallurgical evaluations identified the initial failure as corrosion-accelerated fatigue.

Figure 4: Failed Section of Trash Rack and Details

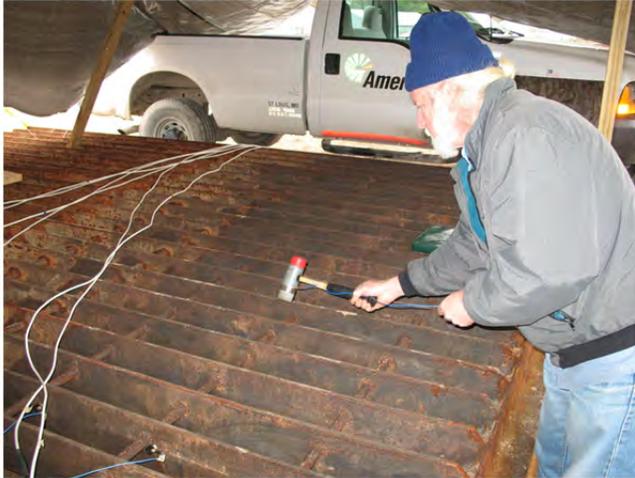
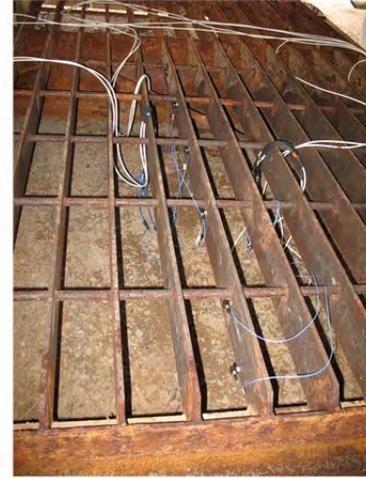
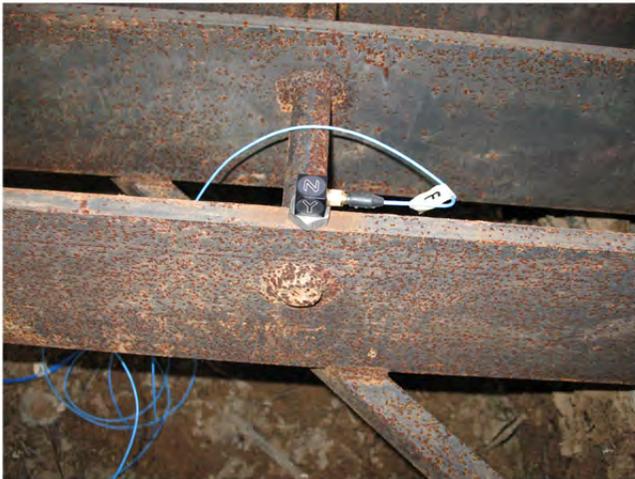
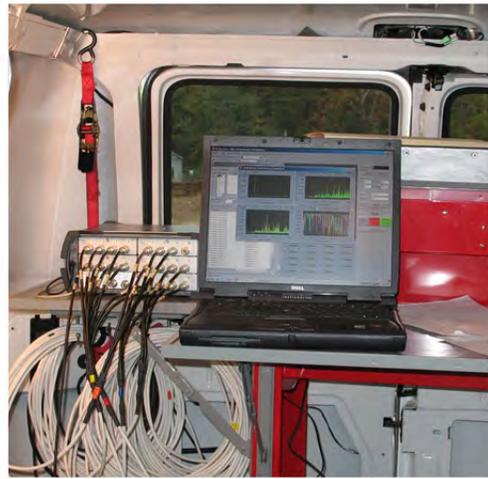
As shown in Figure 5, modal analysis testing was performed by Structural Technology Corporation (STC) on an undamaged trash rack. Results were used to identify likely natural frequencies of the trash rack that could be excited by flow-induced vibrations. The modal

analysis testing utilized the impact-response technique [Ewins, 1984], with frequency response functions measured by tri-axial accelerometers (Figure 5C) at 119 measurement points (Figure 5B) with 114 impact points (Figure 5A). Modal frequencies and shapes for the trash rack were computed from the resulting impact-response transfer functions (Figure 5D) using proprietary STC software.

**A. Modal Analysis Testing Underway**

**B. Response Accelerometers**

**C. View of Tri-axial Accelerometer**

**D. Instrumentation for Data Analysis**

**Figure 5: Modal Analysis Testing of Undamaged Trash Rack**

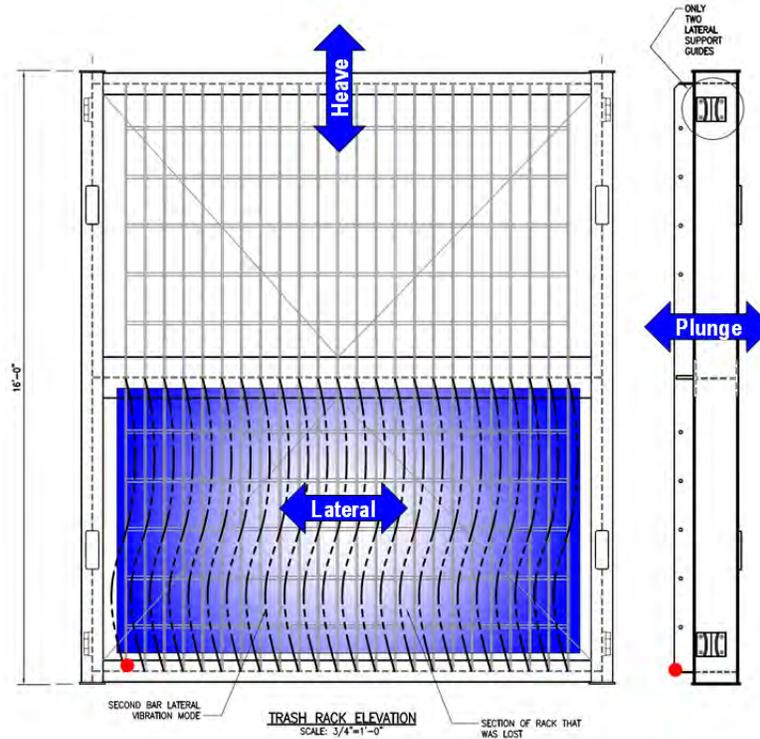
Figure 6 shows ASCE’s recommended nomenclature for vibration modes of trash racks [Crandall et al., 1975; March and Vigander, 1979; ASCE, 1993]. “Heave” is vertical vibration, “lateral” vibration is transverse to the flow, and “plunge” vibration is in the flow direction.

Figure 6: ASCE Nomenclature for Vibration Modes of Trash Racks

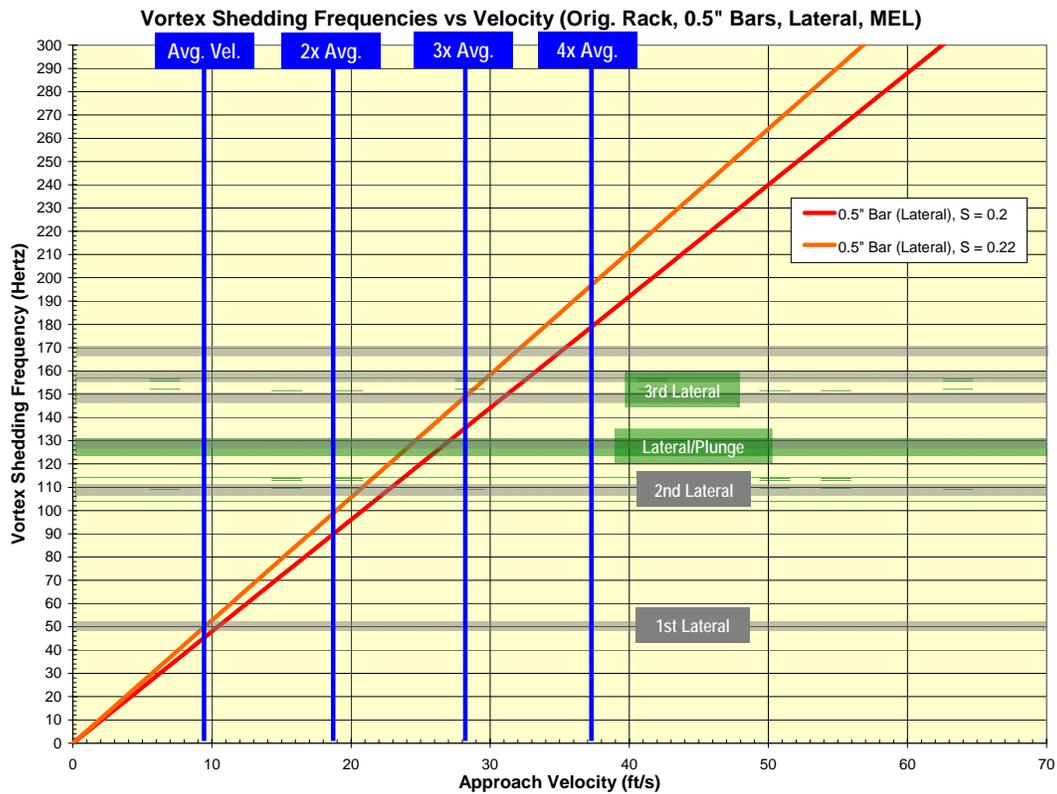
Expected vortex shedding frequencies for all of the primary elements of the original trash rack, including square bars, round rods, and rectangular bars, were computed based on assumed Strouhal Numbers and approach velocities determined from flows at the Most Efficient Load (MEL) and the maximum load. Figure 7 is a typical diagram showing correlation between the expected range of vortex shedding frequencies and the observed lateral natural frequencies for the trash rack bars. The thickness of the horizontal bars showing the lateral mode frequencies represents the small anticipated decrease in frequency associated with the added-mass effect when the trash rack is vibrating in water rather than air [March and Vigander, 1982; Blevins, 1984; Blevins, 1990]. Similar diagrams were also developed and evaluated for heave modes and plunge modes at both MEL flows and maximum flows.

Figure 7: Correlation between Vortex Shedding Frequencies and Trash Rack Vibration Modes (Original Rack Design)

The lateral modes are displayed in Figure 7 because these modes are consistent with the fatigue cracking observed in the lower portion of the bars. The first lateral mode, shown in Figure 7 in the vicinity of 50 Hz, lines up with the vortex shedding frequency produced by the average approach velocity during normal generating. However, if this mode was responsible for the rack failure, the failure would not have been localized to the velocity “hot spot.”

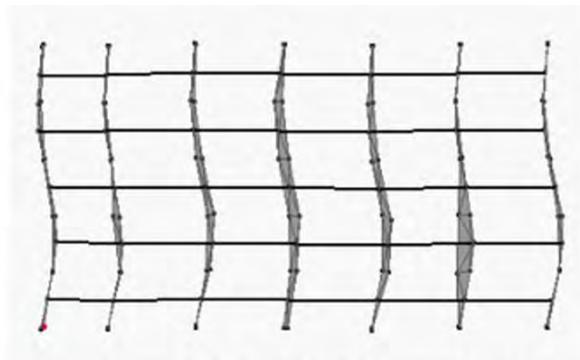
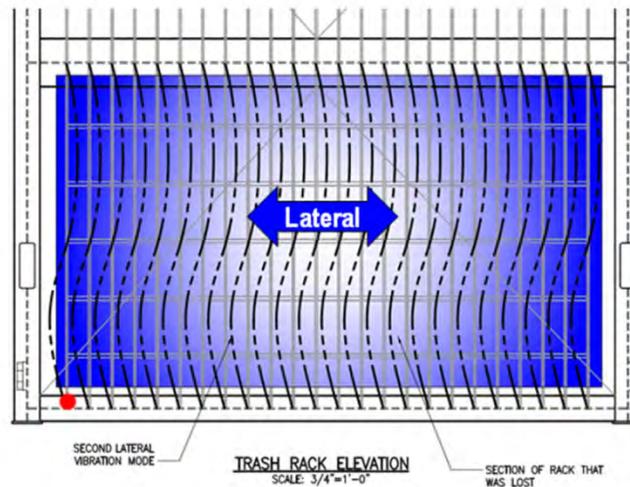
The second lateral mode (106.5 Hz in air) is a more likely candidate for involvement in the rack failure. The mode shape for the second lateral mode, based on the modal field tests, and a simplified schematic which superimposes the second lateral mode shape onto the missing rack section are shown in Figure 8.

A. Second Lateral Mode at 106.5 Hz (from Field Tests)

B. Simplified Schematic Showing Second Lateral Mode

Figure 8: Modal Analysis Results Showing Second Lateral Mode at 106.5 Hz

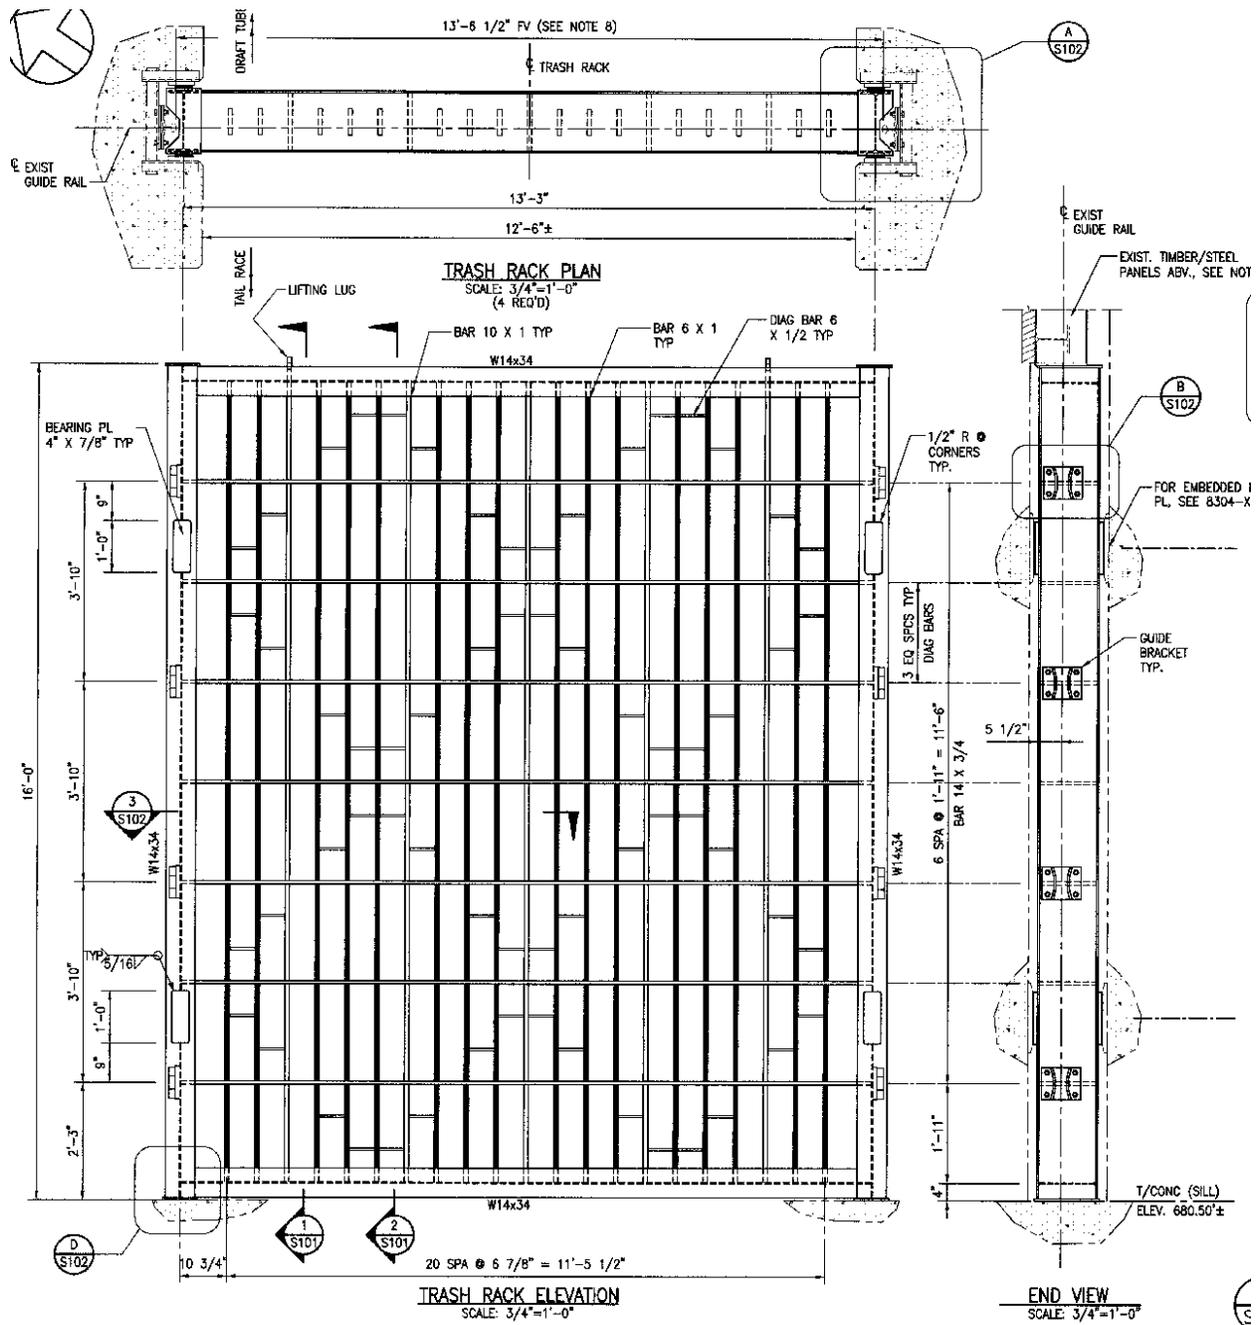
drawings and the fabrication specification. The final design is shown in Figure 9. Typical results from the FEA dynamic analyses are shown as modal frequencies in the correlation diagram of Figure 10, which provides results for lateral vibration modes. Similar diagrams were also developed and evaluated for heave modes and plunge modes at both MEL flows and maximum flows.

Figure 9: Design of New Trash Rack

HPPi provided a preliminary trash rack design based on a previously successful design for a draft tube trash rack [Schohl and March, 1982] and design criteria developed from the forensic analysis, the ASCE task force's recommendations [ASCE, 1993], and ASME recommendations [ASME, 1996]. The design criteria incorporated the following features:

- Varied bar dimensions and spacing to minimize effects of compounding stimuli from vortex shedding on adjacent bars;
- Increased bar thickness to increase stiffness;
- Increased section dimensions and weld geometry for design flows and trash loading;
- Minimized cross section area to limit effects on unit performance.

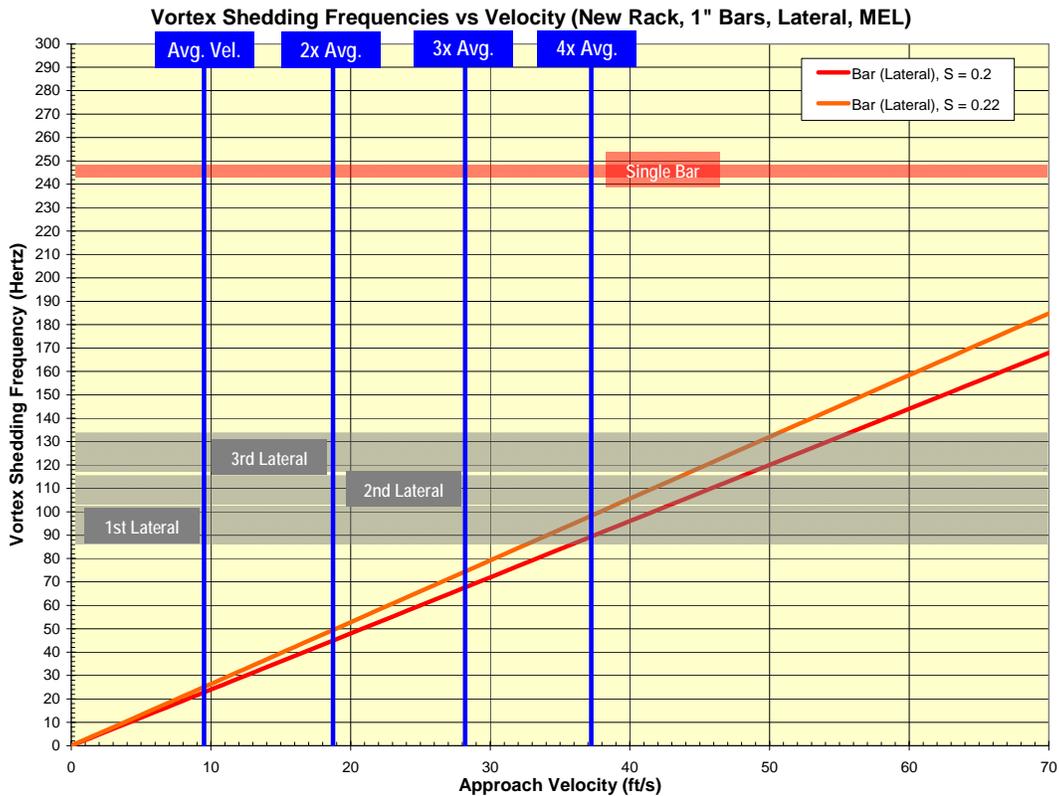
Figure 10: Correlation between Vortex Shedding Frequencies and Trash Rack Vibration Modes (New Rack Design)

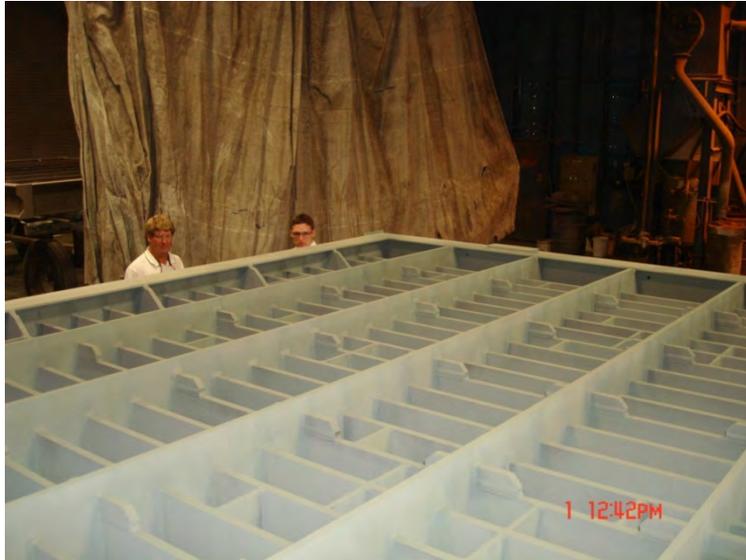
A local steel fabricator was selected from several bidders. Work was monitored and inspected throughout the fabrication process to ensure quality, and the fabrication proceeded smoothly. Figure 11 shows one of the new racks in the fabrication shop.

Figure 11: New Trash Rack in Fabrication Shop

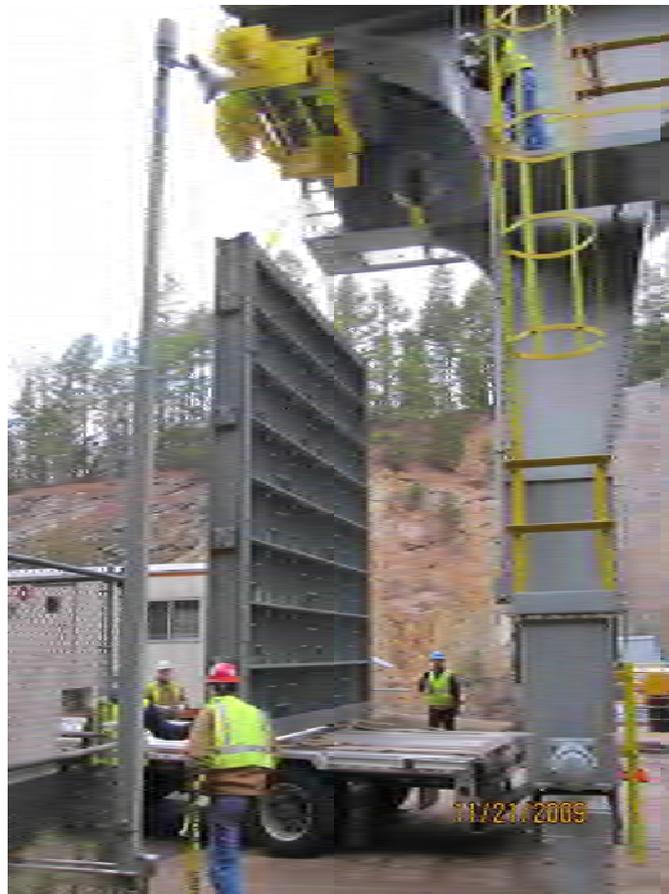
Figure 12: New Trash Rack during Unloading at Plant

The new trash racks were returned to service in the Spring of 2010 (see Figure 12 and Figure 13). The Taum Sauk units have been in operation for 27 months. cursory inspections of the draft tube trash racks have been performed by divers during unit outages. No failures or indications of other problems have been found. In March 2012, divers performed an extensive underwater inspection of the trash racks. All section members were inspected and visually confirmed by camera (see Figure 14). No degradation, indications of cracking, or other problems were found.

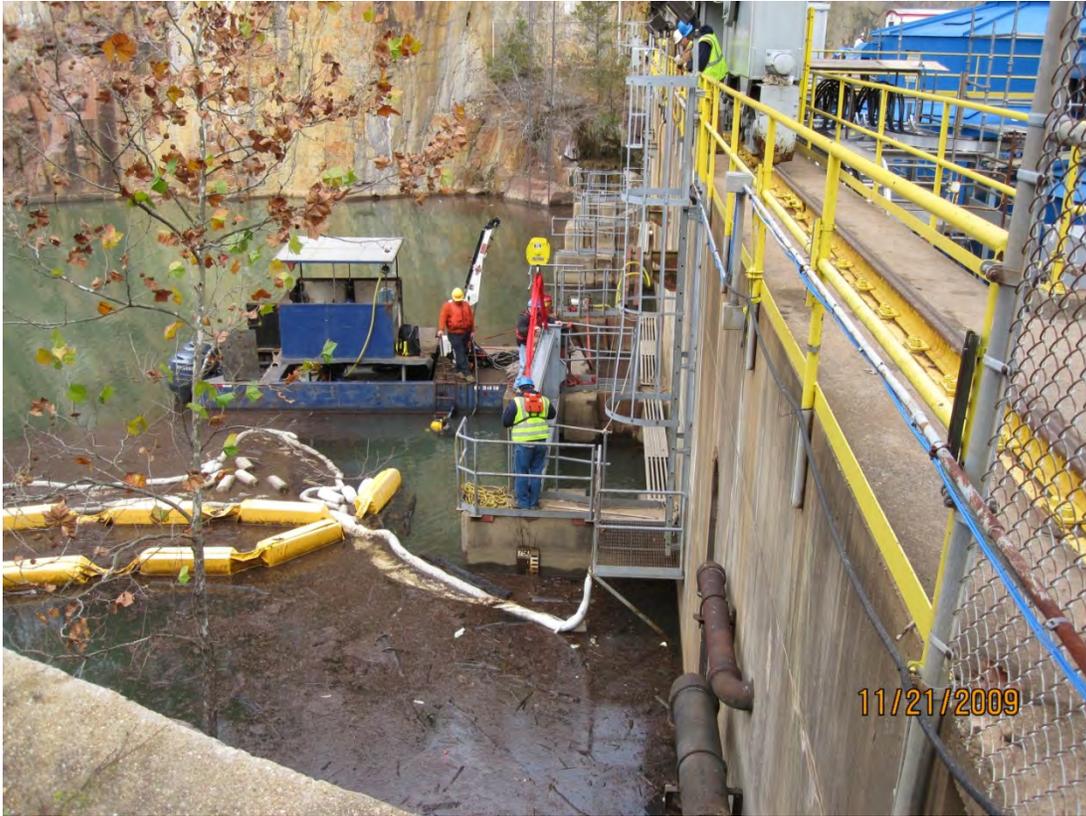
Figure 13: New Trash Rack during Installation at Plant

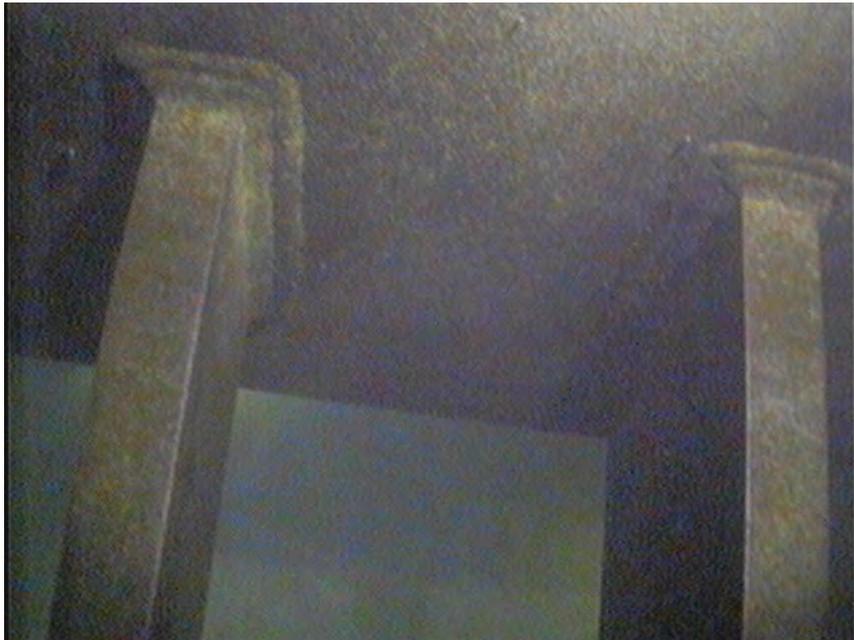
Figure 14: Typical View during Trash Rack Inspection
